EVALUATION OF FRAMED WALL CONSTRUCTION SECTIONS UTILIZING LATICRETE INTERNATIONAL'S "LATICRETE BUILDING ENVELOPE SYSTEM" AIR BARRIER SYSTEM IN ACCORDANCE WITH ASTM E2357-11

12-06-M0324-1 17 Pages, 5 Appendices

January 29, 2013

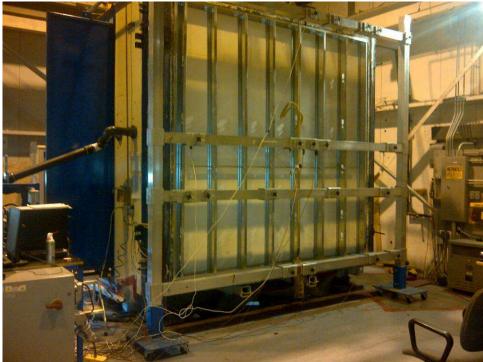
Figure 2 – Specimen Installation in Chamber (Outside Chamber View) Wall Specimen 1

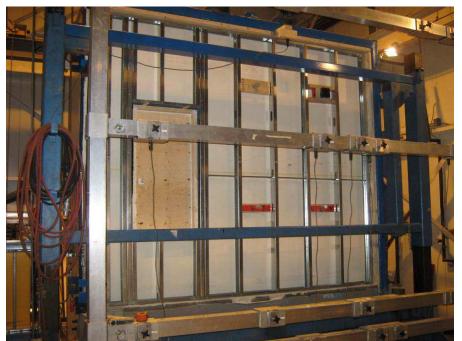
Figure 3 – Specimen Installed in Chamber (Outside View) Wall Specimen 2+3

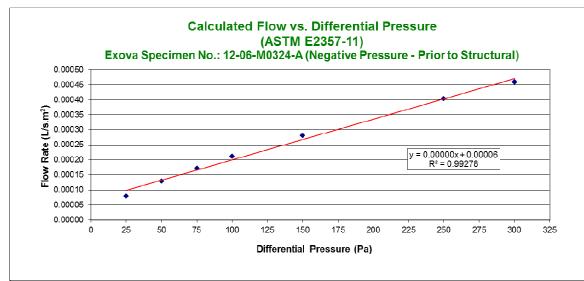
Figure 4 – Exova Specimen No.: 12-06-M0324-A Exfiltration Air Leakage Prior to Structural Loading

| Table 2 - Summarized Air Leakage Results in Accordance with ASTM E2357-11 - Section 9.1, Air Leakage Testing Exova Specimen No.: 12-06-M0324-A (Exfiltration '-') | | | | | | | | |

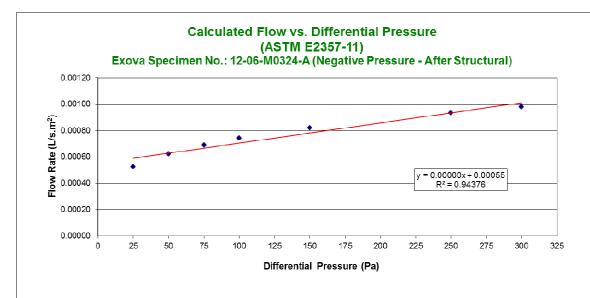
Figure 5 – Exova Specimen No.: 12-06-M0324-A Exfiltration Air Leakage After Structural Loading

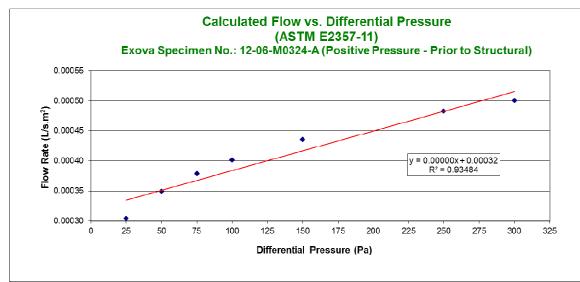
Figure 6 – Exova Specimen No.: 12-06-M0324-A Infiltration Air Leakage Prior to Structural Loading

| Table 3 - Summarized Air Leakage Results in Accordance with ASTM E2357-11 - Section 9.1, Air Leakage Testing Exova Specimen No.: 12-06-M0324-A (Infiltration '+') | | | | | | | | |

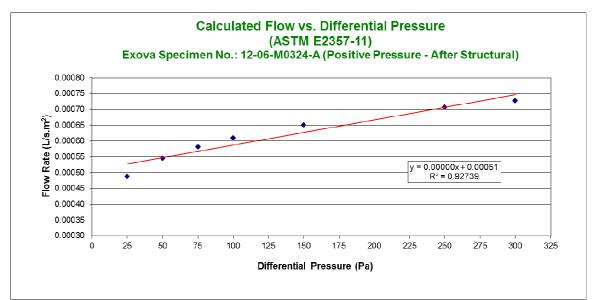
Figure 7 – Exova Specimen No.: 12-06-M0324-A Infiltration Air Leakage After Structural Loading

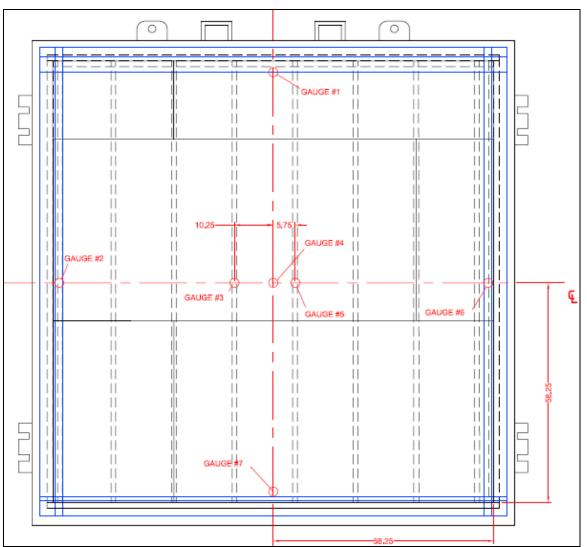
Figure 8 – Exova Specimen 12-06-M0324-A Gauge Locations

Note: The locations for each gauge number are located on the following page in Figure 8.

During the wind loading schedule as shown in Tables 4 and 5, there were no visible signs of Exova Specimen No. 12-06-M0324-A (air barrier material) tearing, peeling or cracking from the sheathed wall section.

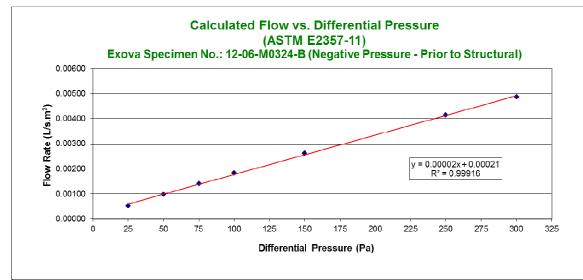
Figure 9 – Exova Specimen No.: 12-06-M0324-B Exfiltration Air Leakage Prior to Structural Loading

| Table 6 - Summarized Air Leakage Results in Accordance with ASTM E2357-11 - Section 9.1, Air Leakage Testing Exova Specimen No.: 12-06-M0324-B (Exfiltration '-') | | | | | | | |

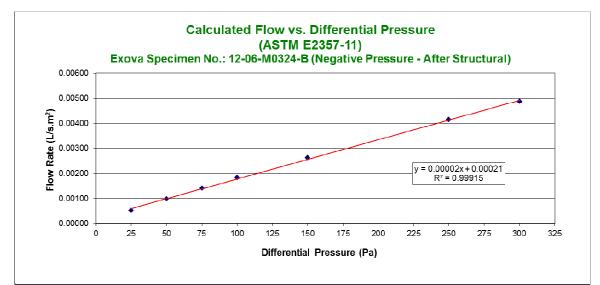
Figure 10 – Exova Specimen No.: 12-06-M0324-B Exfiltration Air Leakage After Structural Loading

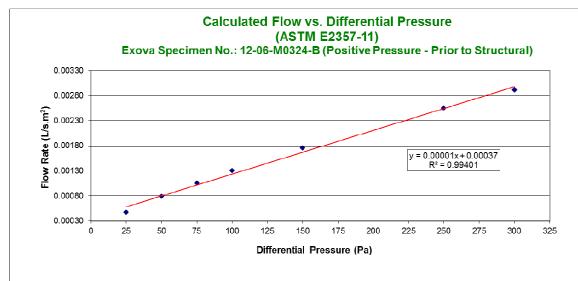
Figure 11 – Exova Specimen No.: 12-06-M0324-B Infiltration Air Leakage Prior to Structural Loading

| Table 7 - Summarized Air Leakage Results in Accordance with ASTM E2357-11 - Section 9.1, Air Leakage Testing Exova Specimen No.: 12-06-M0324-B (Infiltration '+') | | | | | | | | |

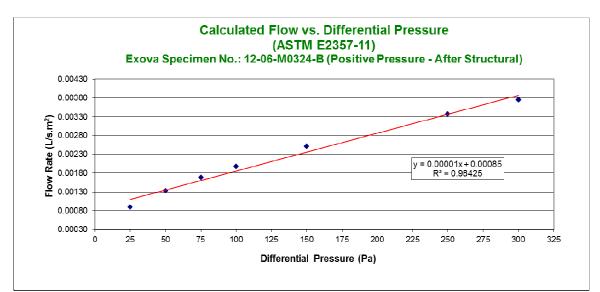
Figure 12 – Exova Specimen No.: 12-06-M0324-B Infiltration Air Leakage After Structural Loading

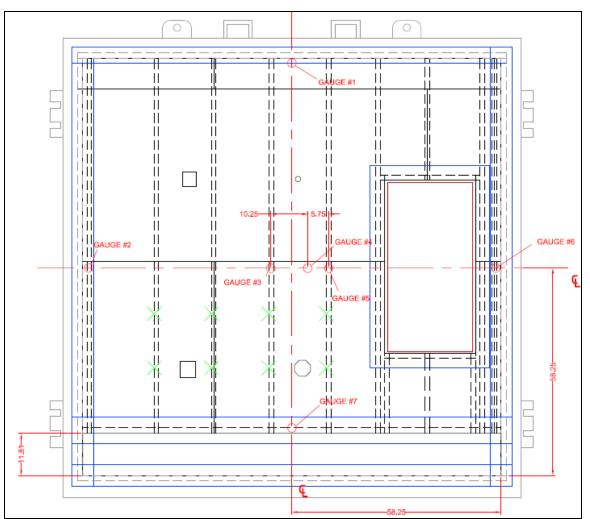
Figure 13 – Exova Specimen 12-06-M0324-B Gauge and Penetration Locations

Note: The locations for each gauge number are located on the following page in Figure 13.

During the wind loading schedule as shown in Tables 8 and 9, there were no visible signs of Exova Specimen No. 12-06-M0324-B (air barrier material) tearing, peeling or cracking from the sheathed wall section.

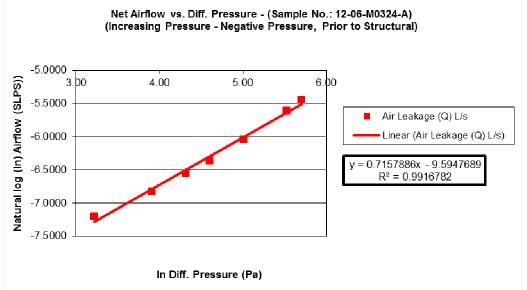
Figure B-1 – Exova Specimen 12-06-M0324-A Exfiltration Log/Log Graph Prior to Structural Cycling

As per ASTM E2357-05, Section 11.2.1.4 logarithmic graphs for each air leakage test (infiltration/exfiltration) displaying the linear regression ($r^2 \ge 0.95$) values are located in Appendices B & C.

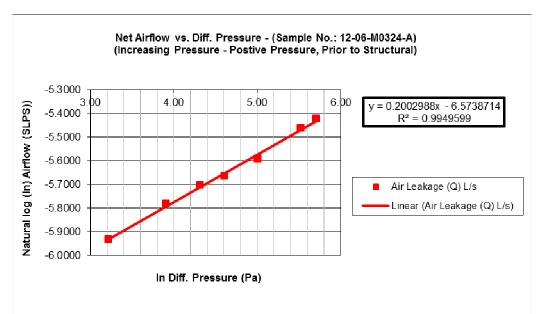
Figure B-2 – Exova Specimen 12-06-M0324-A Infiltration Log/Log Graph Prior to Structural Cycling

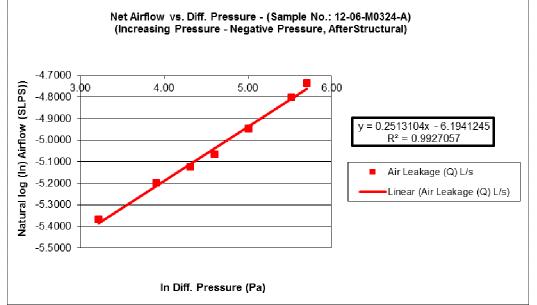
Figure B-3 – Exova Specimen 12-06-M0324-A Exfiltration Log/Log Graph After Structural Cycling

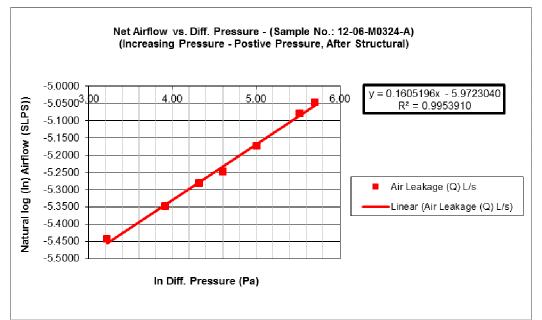
Figure B-4 – Exova Specimen 12-06-M0324-A Infiltration Log/Log Graph After Structural Cycling

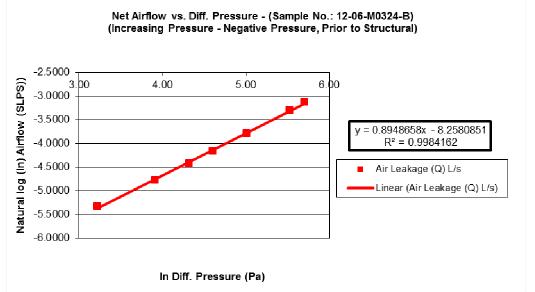
Figure C-1 – Exova Specimen 12-06-M0324-B Exfiltration Log/Log Graph Prior to Structural Cycling

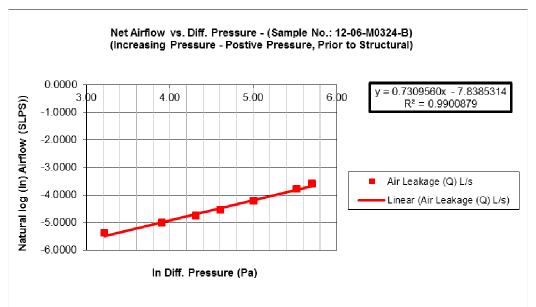
Figure C-2 – Exova Specimen 12-06-M0324-B Infiltration Log/Log Graph Prior to Structural Cycling

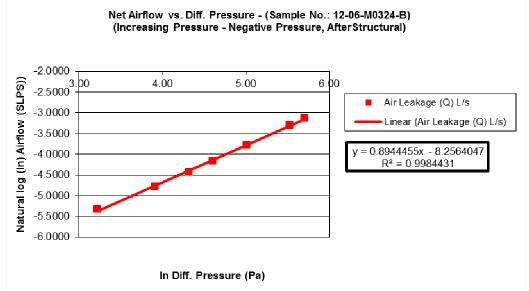
Figure C-3 – Exova Specimen 12-06-M0324-B Exfiltration Log/Log Graph After Structural Cycling

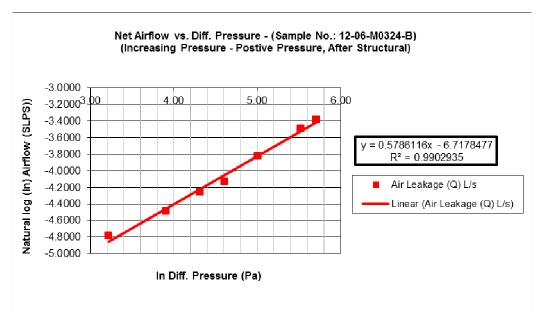
Figure C-4 – Exova Specimen 12-06-M0324-B Infiltration Log/Log Graph After Structural Cycling

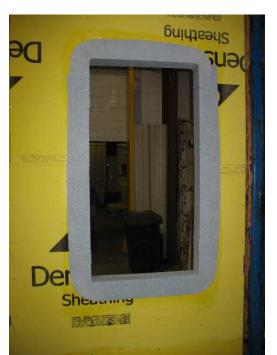
Figure E-1 – Application of LATICRETE Flexible Sealing Tape around Window Rough Opening

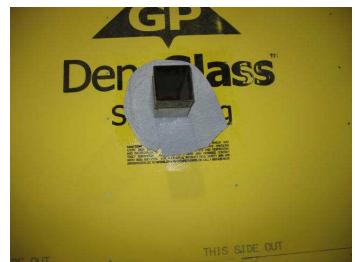
Figure E-2 – Application of LATICRETE Flexible Sealing Tape around Duct

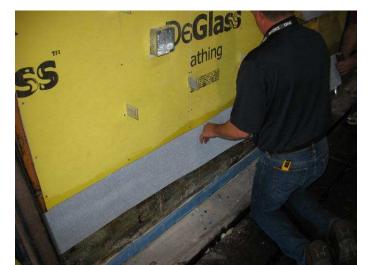
Figure E-3 – Application of LATICRETE Flexible Sealing Tape along Concrete Foundation Interface

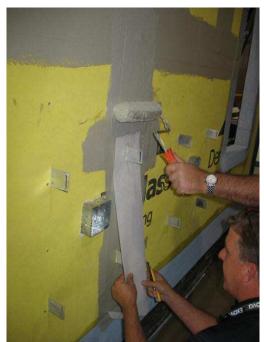
Figure E-5 – Application of LATICRETE Waterproof/Anti-Fracture Fabric along Sheathing Joint / Brick Ties

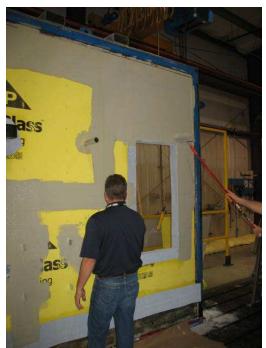
Figure E-6 – Application of LATICRETE Air & Water Barrier

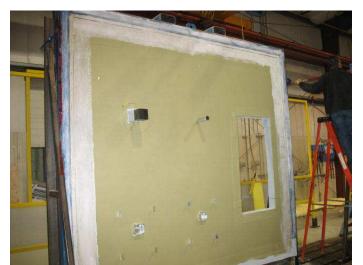
Figure E-9 – Application of LATICRETE Transition Tape Primer around Perimeter Wall / Specimen Transporter Frame Interface

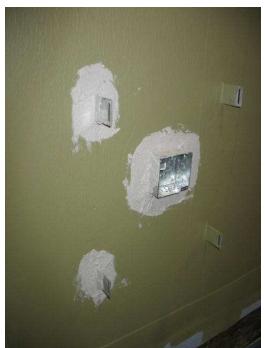
Figure E-10 – Application of LATAPOXY Waterproof Flashing Mortar around Brick Ties and Square Electrical Junction Box / Adjacent Brick Ties Sealed with LATICRETE Air & Water Barrier

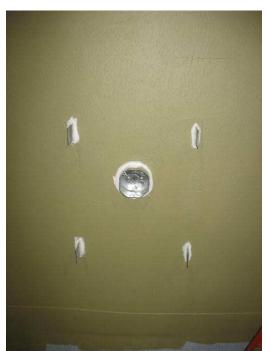
Figure E-11 – Application of MVIS Silicone Sealant around Brick Ties and Hexagonal Electrical Junction Box
