EVALUATION OF FRAMED WALL CONSTRUCTION SECTIONS UTILIZING LATICRETE INTERNATIONAL'S "LATICRETE BUILDING ENVELOPE SYSTEM" AIR BARRIER SYSTEM IN ACCORDANCE WITH CAN/ULC S742-11

LATICRETE International Inc. One LATICRETE Park North Bethany, CT. 06524-3423 USA

12-06-M0324-2

March 19, 2013

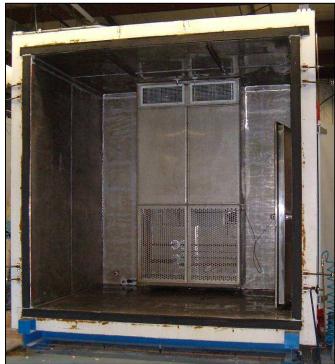
Figure 1 – Hygrothermal Chamber Prior to Specimen Installation Displaying Location of Air Seal

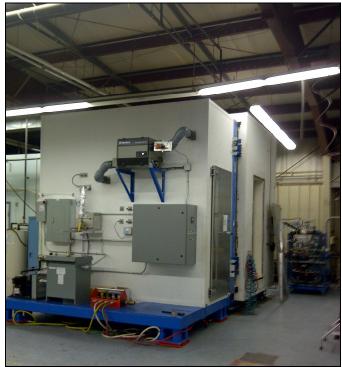
Figure 2 – General Specimen Installation between Warm Side and Hygrothermal Chamber

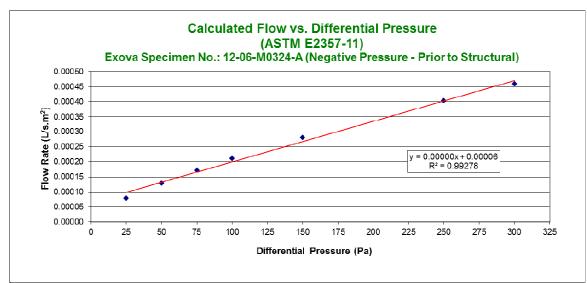
Figure 3– Exova Specimen No.: 12-06-M0324-A Exfiltration Air Leakage Prior to Wind Conditioning

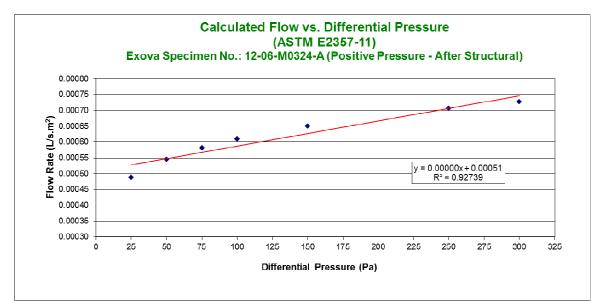
Figure 6- Exova Specimen No.: 12-06-M0324-A Infiltration Air Leakage After Wind Conditioning (Ambient)

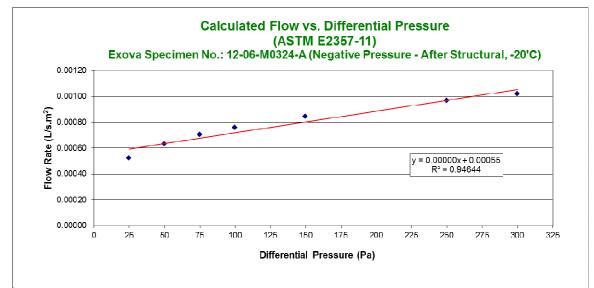
Figure 7 - Exova Specimen No.: 12-06-M0324-A Exfiltration Air Leakage After Wind Conditioning (Cold)

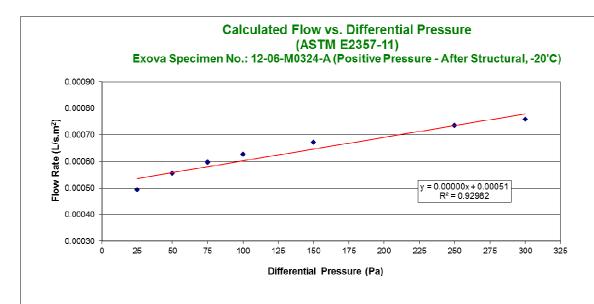
Figure 8– Exova Specimen No.: 12-06-M0324-A Infiltration Air Leakage After Wind Conditioning (Cold)

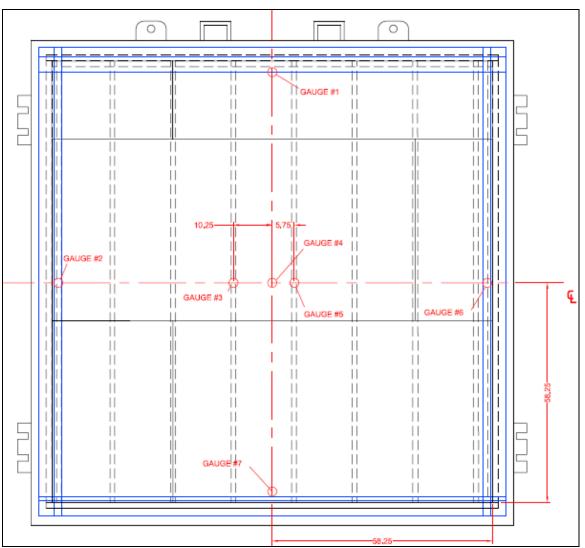
Figure 9 – Exova Specimen 12-06-M0324-A Gauge Locations

Note: The locations for each gauge number are located on the following page in Figure 9.

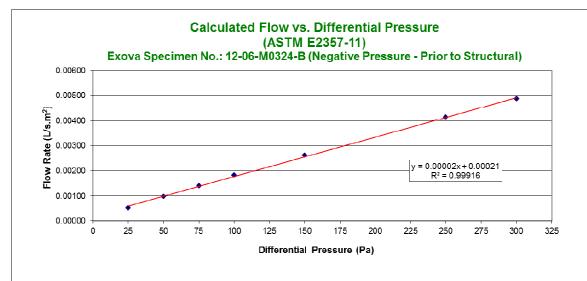
Figure 10 – Exova Specimen No.: 12-06-M0324-B Exfiltration Air Leakage Prior to Wind Conditioning

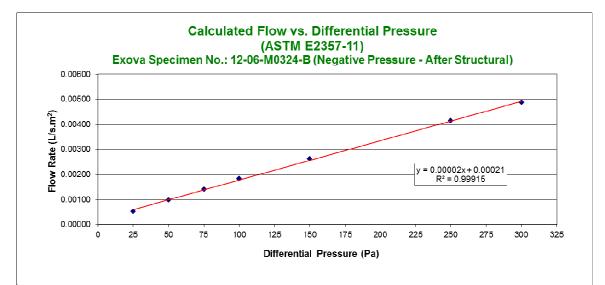
Figure 11 – Exova Specimen No.: 12-06-M0324-B Infiltration Air Leakage Prior to Wind Conditioning

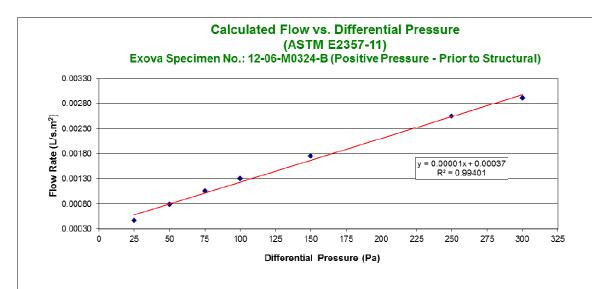
Figure 12 – Exova Specimen No.: 12-06-M0324-B Exfiltration Air Leakage After Wind Conditioning (Ambient)

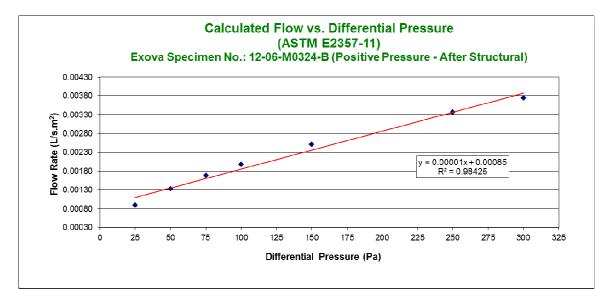
Figure 13 – Exova Specimen No.: 12-06-M0324-B Infiltration Air Leakage After Wind Conditioning (Ambient)

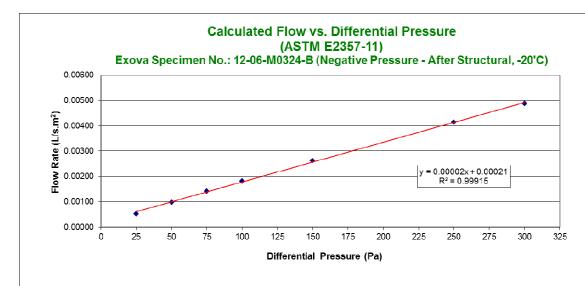
Figure 14 - Exova Specimen No.: 12-06-M0324-B Exfiltration Air Leakage After Wind Conditioning (Cold)

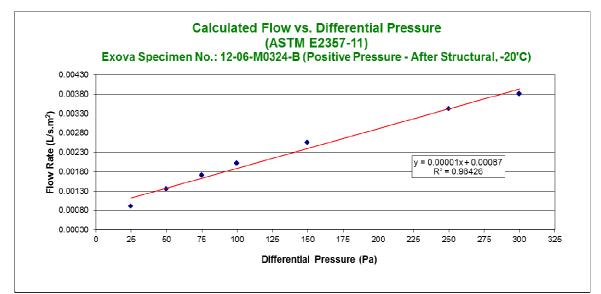
Figure 15 – Exova Specimen No.: 12-06-M0324-B Infiltration Air Leakage After Wind Conditioning (Cold)

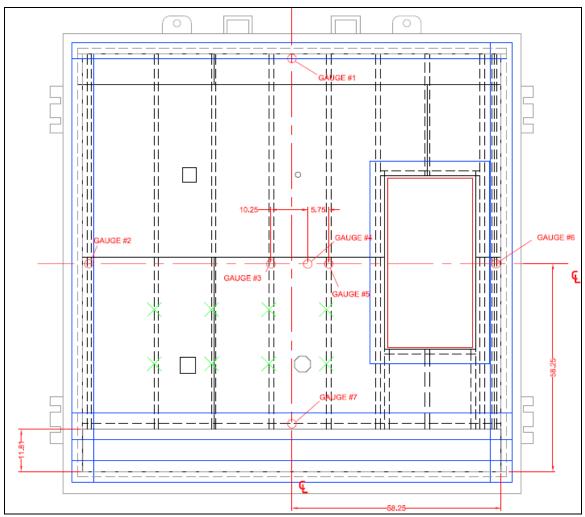
Figure 16 – Exova Specimen 12-06-M0324-B Gauge Locations

Note: The locations for each gauge number are located on the following page in Figure 16.

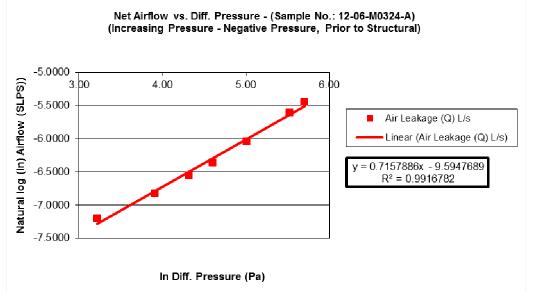
Figure B-1 – Exova Specimen 12-06-M0324-A Exfiltration Log/Log Graph Prior to Structural Cycling

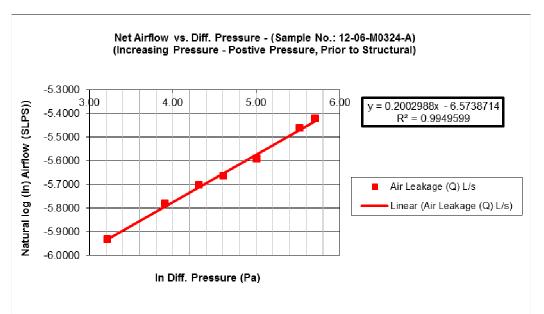
Figure B-2 – Exova Specimen 12-06-M0324-A Infiltration Log/Log Graph Prior to Structural Cycling

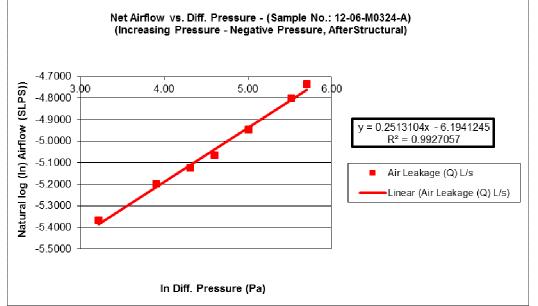
Figure B-3 – Exova Specimen 12-06-M0324-A Exfiltration Log/Log Graph After Structural Cycling

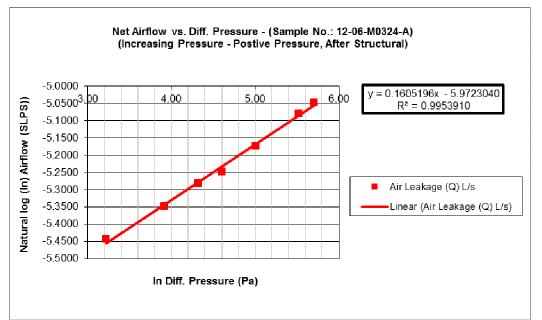
Figure B-4 – Exova Specimen 12-06-M0324-A Infiltration Log/Log Graph After Structural Cycling

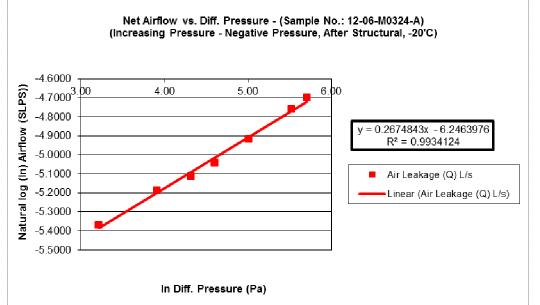
Figure B-5 – Exova Specimen 12-06-M0324-A Exfiltration Log/Log Graph After Structural Cycling (Cold)

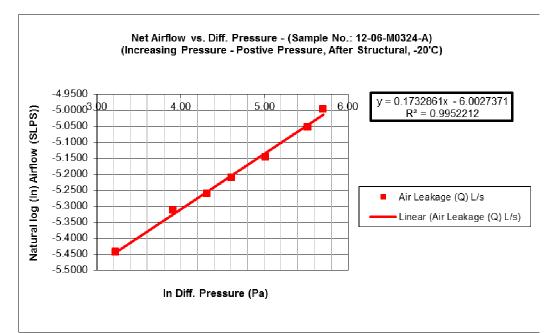
Figure B-6 – Exova Specimen 12-06-M0324-A Infiltration Log/Log Graph After Structural Cycling (Cold)

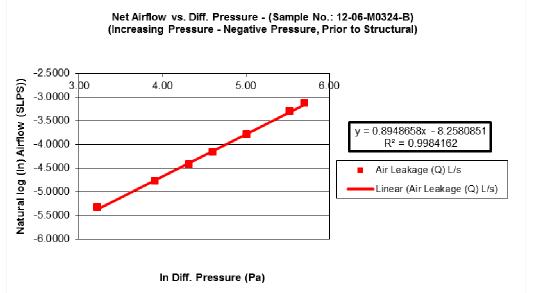
Figure C-1 – Exova Specimen 12-06-M0324-B Exfiltration Log/Log Graph Prior to Structural Cycling

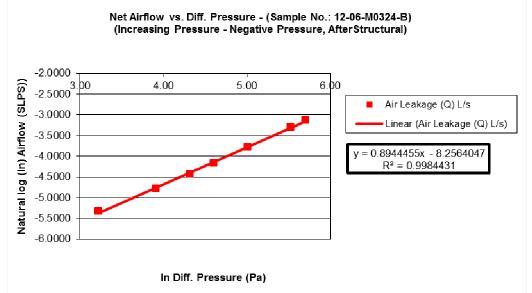
Figure C-3 – Exova Specimen 12-06-M0324-B Exfiltration Log/Log Graph After Structural Cycling

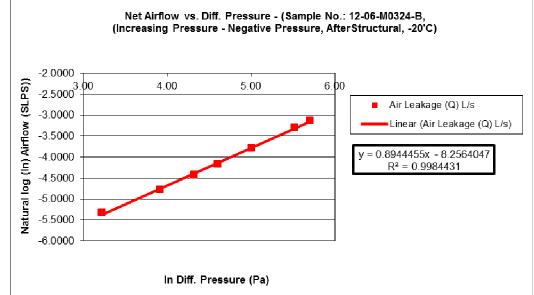
Figure C-5 – Exova Specimen 12-06-M0324-B Exfiltration Log/Log Graph After Structural Cycling (Cold)

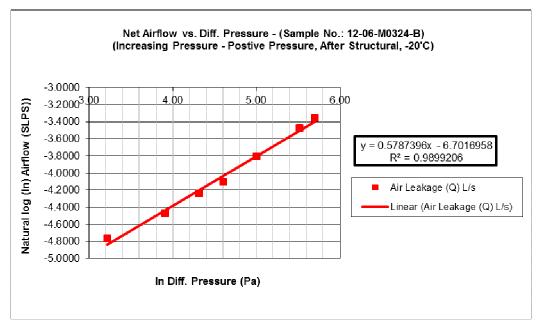
Figure C-6 – Exova Specimen 12-06-M0324-B Infiltration Log/Log Graph After Structural Cycling (Cold)

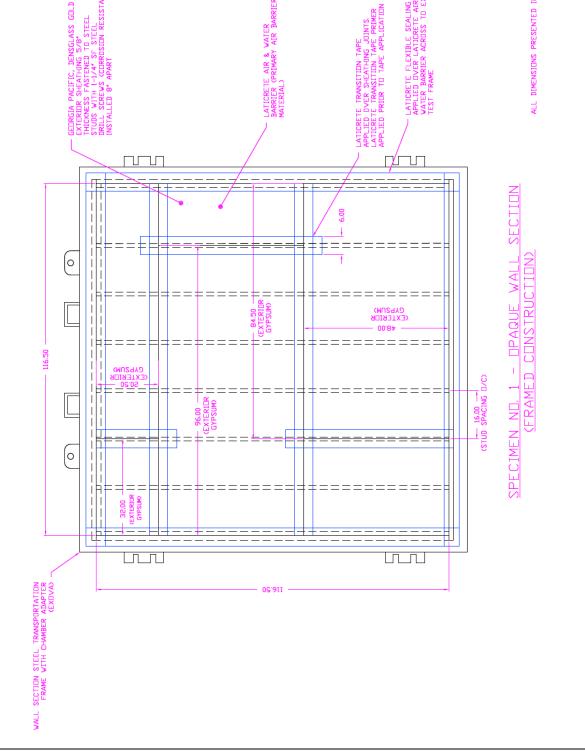
Figure D-1 – Sheathed Opaque Wall Section (Sheathing Joints Sealed and First Coat of LATICRETE Air & Water Barrier Applied)

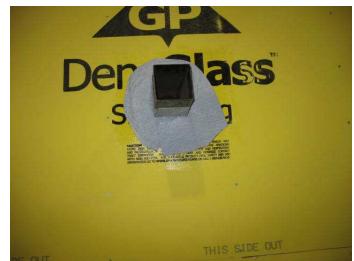
Figure E-2 – Application of LATICRETE Flexible Sealing Tape around Duct

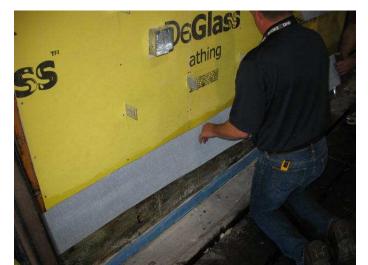
Figure E-3 – Application of LATICRETE Flexible Sealing Tape along Concrete Foundation Interface

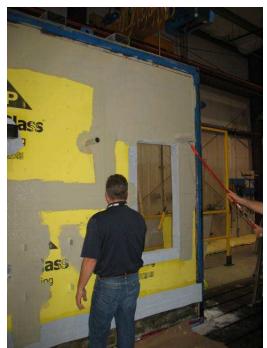
Figure E-6 – Application of LATICRETE Air & Water Barrier

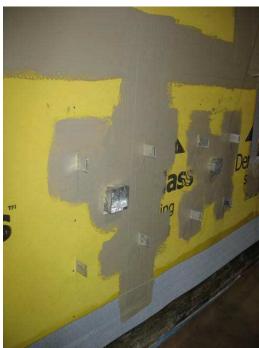
Figure E-7 – Application of LATICRETE Air & Water Barrier

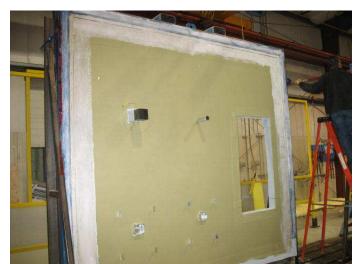
Figure E-9 – Application of LATICRETE Transition Tape Primer around Perimeter Wall / Specimen Transporter Frame Interface

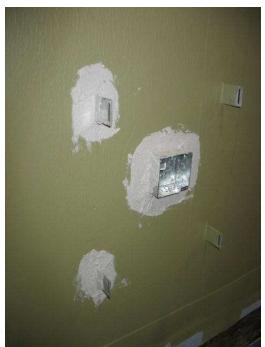
Figure E-10 – Application of LATAPOXY Waterproof Flashing Mortar around Brick Ties and Square Electrical Junction Box / Adjacent Brick Ties Sealed with LATICRETE Air & Water Barrier

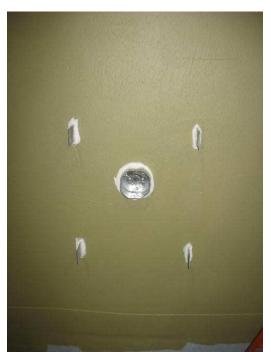
Figure E-11 – Application of MVIS Silicone Sealant around Brick Ties and Hexagonal Electrical Junction Box
