LATICRETE INTERNATIONAL ACOUSTICAL PERFORMANCE TEST REPORT

ASTM E90, ASTM E492, AND ASTM E2179 TESTING ON
CERAMIC TILE OVER LATICRETE 170 3 MM RUBBER UNDERLayment

Concrete Slab - 152 mm

S8152.01-113-11-R0

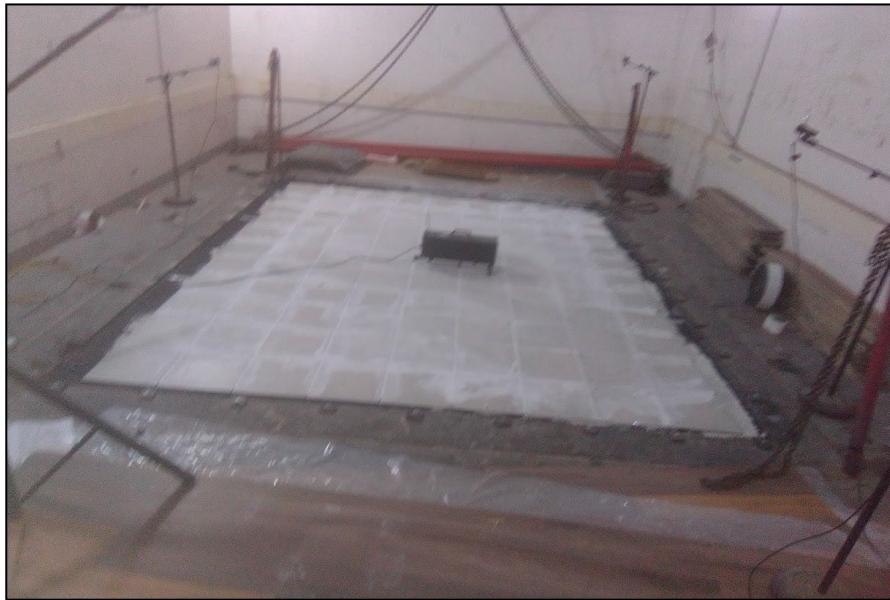
**Photo No. 1
Source Room View of Test Specimen Installation**

The full test specimen was assembled on the day of testing by B&C. All materials provided by the client were installed on an existing B&C assembly (Concrete Slab - 152 mm) utilizing B&C-supplied materials. The assembly was installed in a steel test frame which was installed into the opening between the source and receive rooms in the test chamber. The test frame was isolated from the structure with dense neoprene gasket.

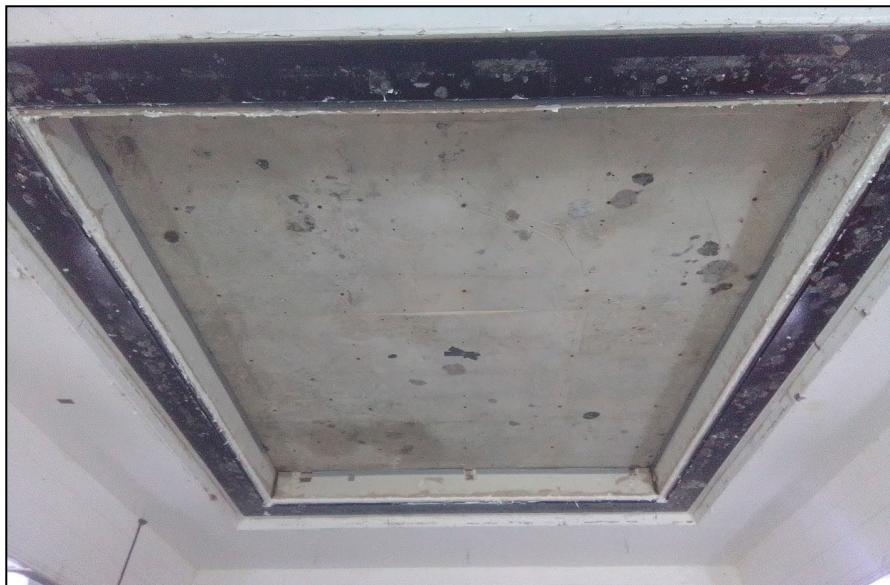
**Photo No. 2
Receive Room View of Test Specimen Installation**
